TRANSMISSION THERMAL MAPPING (UH-1
MAIN ROTOR TRANSMISSION)

Bell Helicopter Company

Final Report

BHC 299-099-652

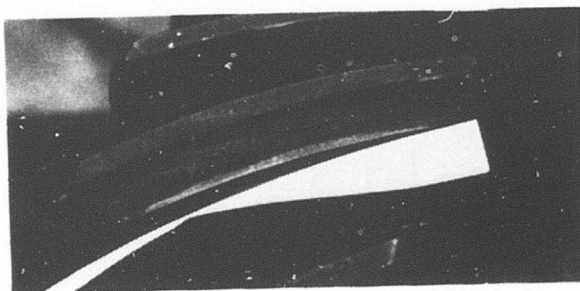
Figure 21. Condition of Main Input Pinion at End of Run 2B, Operational Check.

Figure 22. Condition of Main Input Gear at End of Run 2B, Operational Check.

Upon disassembly of the transmission following the operational test, it was noted that light scoring was present on the main input spiral bevel pinion and gear set due to an incorrect shim placement. Figures 21 and 22 show the condition of both gears. Further inspection showed that all bond on thermal plaques had been dislodged from the surfaces to which it had been attached. The slipring installed inside the shaft of the input pinion had been damaged as a result of the stationary outer ring coming in contact with the rotating driving member. This contact had generated enough heat in the area where the wires exited the slipring that all insulation was melted from the wiring. This necessitated the replacement of the slipring. All other components were in good condition with no indicated pattern change.

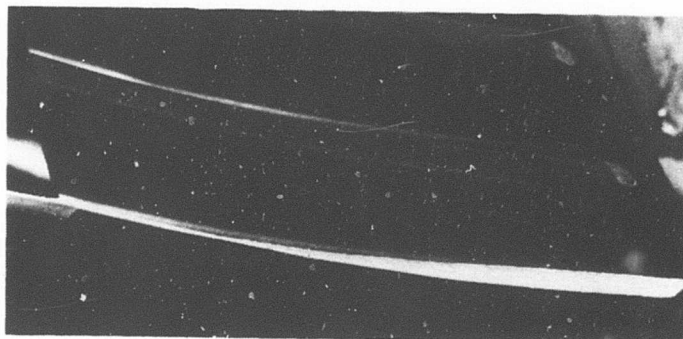
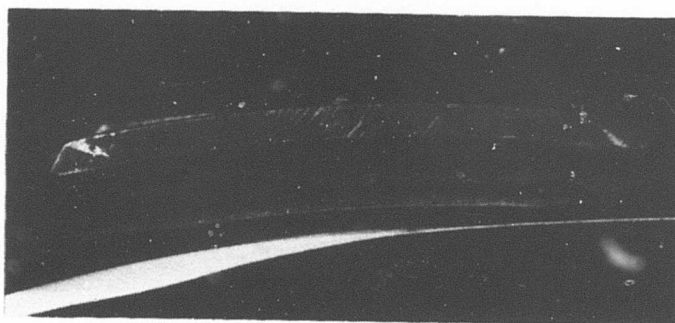
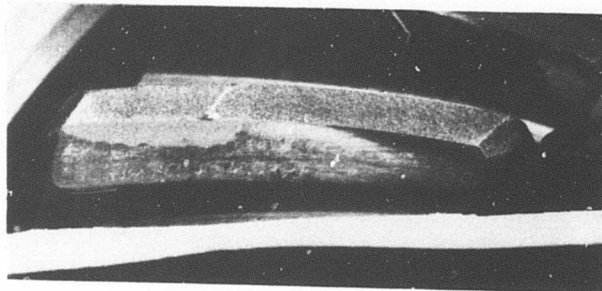
Figure 48. Input Bevel Gear Following Final Test Run at $345^{\circ}\pm 5^{\circ}\text{F}$ Oil-Out Temperature.

Figure 49. Input Bevel Pinion Following Final Test Run at $345^{\circ}\pm 5^{\circ}\text{F}$ Oil-Out Temperature.

Figure 50. Lower Planetary Pinion Sun Gear Side
Following $345^{\circ}\pm 5^{\circ}\text{F}$ Oil-Out Temperature.

Figure 51. Lower Planetary Pinion Ring Gear Side
Following $345^{\circ}\pm 5^{\circ}\text{F}$ Oil-Out Temperature.

Figure 52. Upper Sun Gear Following $345^{\circ}\pm 5^{\circ}\text{F}$ Oil-Out Temperature.

Figure 53. Lower Sun Gear Following $345^{\circ}\pm 5^{\circ}\text{F}$ Oil-Out Temperature. Arrow Indicates Debris Damage of Unknown Origin.

Figure 54. Sump Output Gear After $345^{\circ}\pm 5^{\circ}\text{F}$ Oil-Out Temperature.

Figure 55. Sump Input Pinion After $345^{\circ}\pm 5^{\circ}\text{F}$ Oil-Out Temperature.

Figure 56. Upper Planetary Pinion Sun Gear Side Following $345^{\circ}\pm 5^{\circ}\text{F}$ Oil-Out Temperature.

Figure 57. Upper Planetary Pinion Ring Gear Side Following $345^{\circ}\pm 5^{\circ}\text{F}$ Oil-Out Temperature.

Test 4 was continued in the same manner as Test 3, with an inspection of the input bevel gear following each segment of the run. Throughout this test run, for all segments, the gear pattern and its placement remained good; no degradation of the observed gear was apparent. The oil leak at the main input pinion steadily increased during each segment until at termination of the final run segment a stream of oil approximately .06 inch in diameter was steadily being ejected from around the seal area. Again it must be stated that the oil temperatures recorded on the thermal maps made during this run (Figures 43, 44, and 45) are not at a true stabilized condition, but were actually rising when the test segment was terminated at the target temperature. This condition was due to the previously explained situation. Figure 46 represents the upper sun gear thermal plaques, and Figure 47 shows the input bevel gear support shaft thermal plaques following this run. Figures 48 through 57 are documentary photographs of all components at the termination of testing.
